Manhole Inspection Summary

Manhole # S19C1_015MH

Location Address: **2701 deering av**

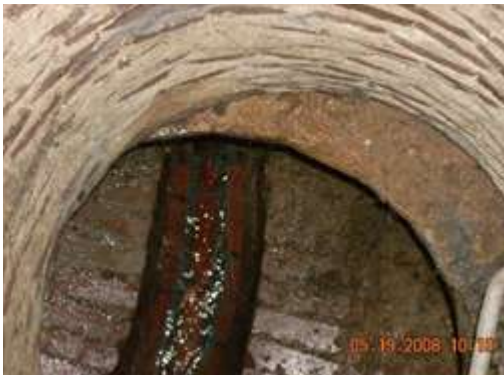
Misc. Defect 3

corbel/barrel offset 8 inches

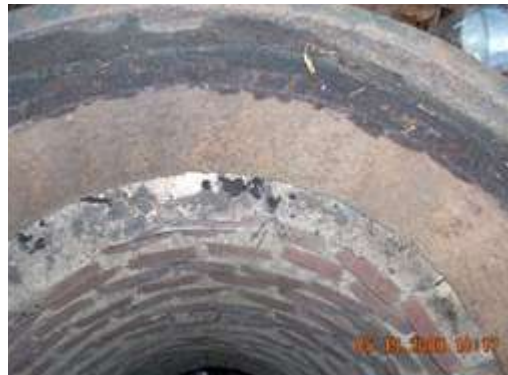
Defect 1

Frame Offset: **2** (in.) Condition: ☒ Sound ☐ Cracked ☐ Leaks

frame offset

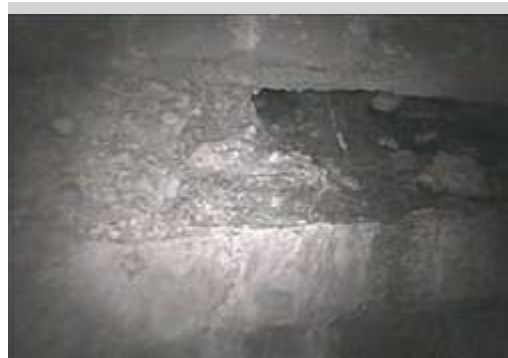
Defect 4

Condition: ☐ Sound ☐ Cracked ☐ Root Intrusion ☐ Loose Brick ☒ **Deteriorated**

deteriorated corbel/barrel joint

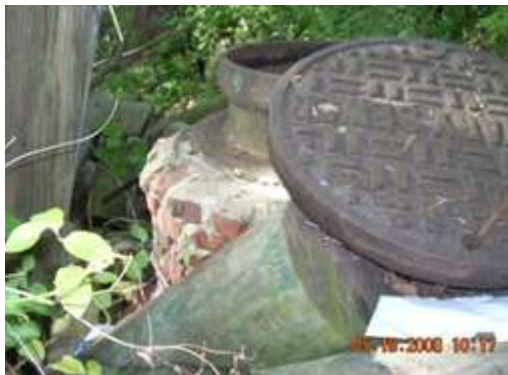
Defect 2

frame above grade

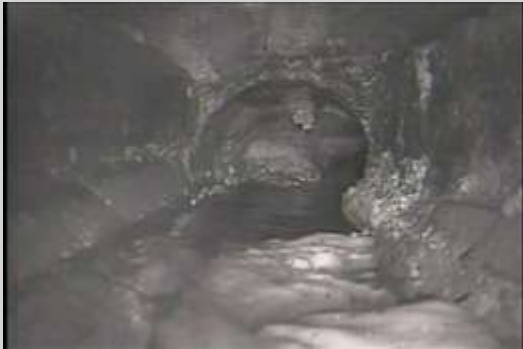
12 O'Clock Outflow

Pipe Height: **8.4** (in.) Rod and Bar (Angled)
Pipe Material: **Clay** ☐ Pipe Lined
Invert Depth: **11.18** (ft.) Flow Characteristics: **Slow**
Deposits: ☐ None ☐ Mud ☒ Sludge ☐ Debris ☒ Grease
Silt Depth: **3** (in.) Deposits Extent: **Medium**
Infiltration: **None** Pipe Seal Cond: **Sound**

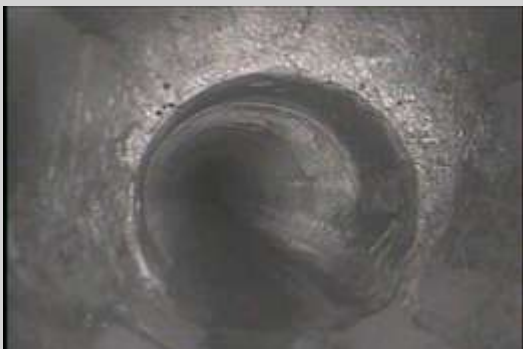
5 O'Clock Inflow

Pipe Height: **8.4** (in.) Rod and Bar (Angled)
Pipe Material: **Clay** ☐ Pipe Lined
Invert Depth: **11.15** (ft.) Flow Characteristics: **Slow**
Deposits: ☒ None ☐ Mud ☐ Sludge ☐ Debris ☐ Grease
Silt Depth: **0** (in.) Deposits Extent:
Infiltration: **None** Pipe Seal Cond: **Sound**
